## Lahars triggered by tropical storms at Volcán de Colima, Mexico: flow characteristics and morphological impact on the volcano slopes

Lucia Capra<sup>1,\*</sup>, Matteo Roverato<sup>2</sup>, Gianluca Groppelli<sup>3</sup>, Víctor Hugo Márquez-Ramírez<sup>1</sup>,  
Juan Carlos Gavilanes-Ruiz<sup>4</sup>, Raul Arambula-Mendoza<sup>5</sup>, Damiano Sarocchi<sup>6</sup>,  
Lorenzo Borselli<sup>6</sup>, and Roberto Sulpizio<sup>6,7</sup>

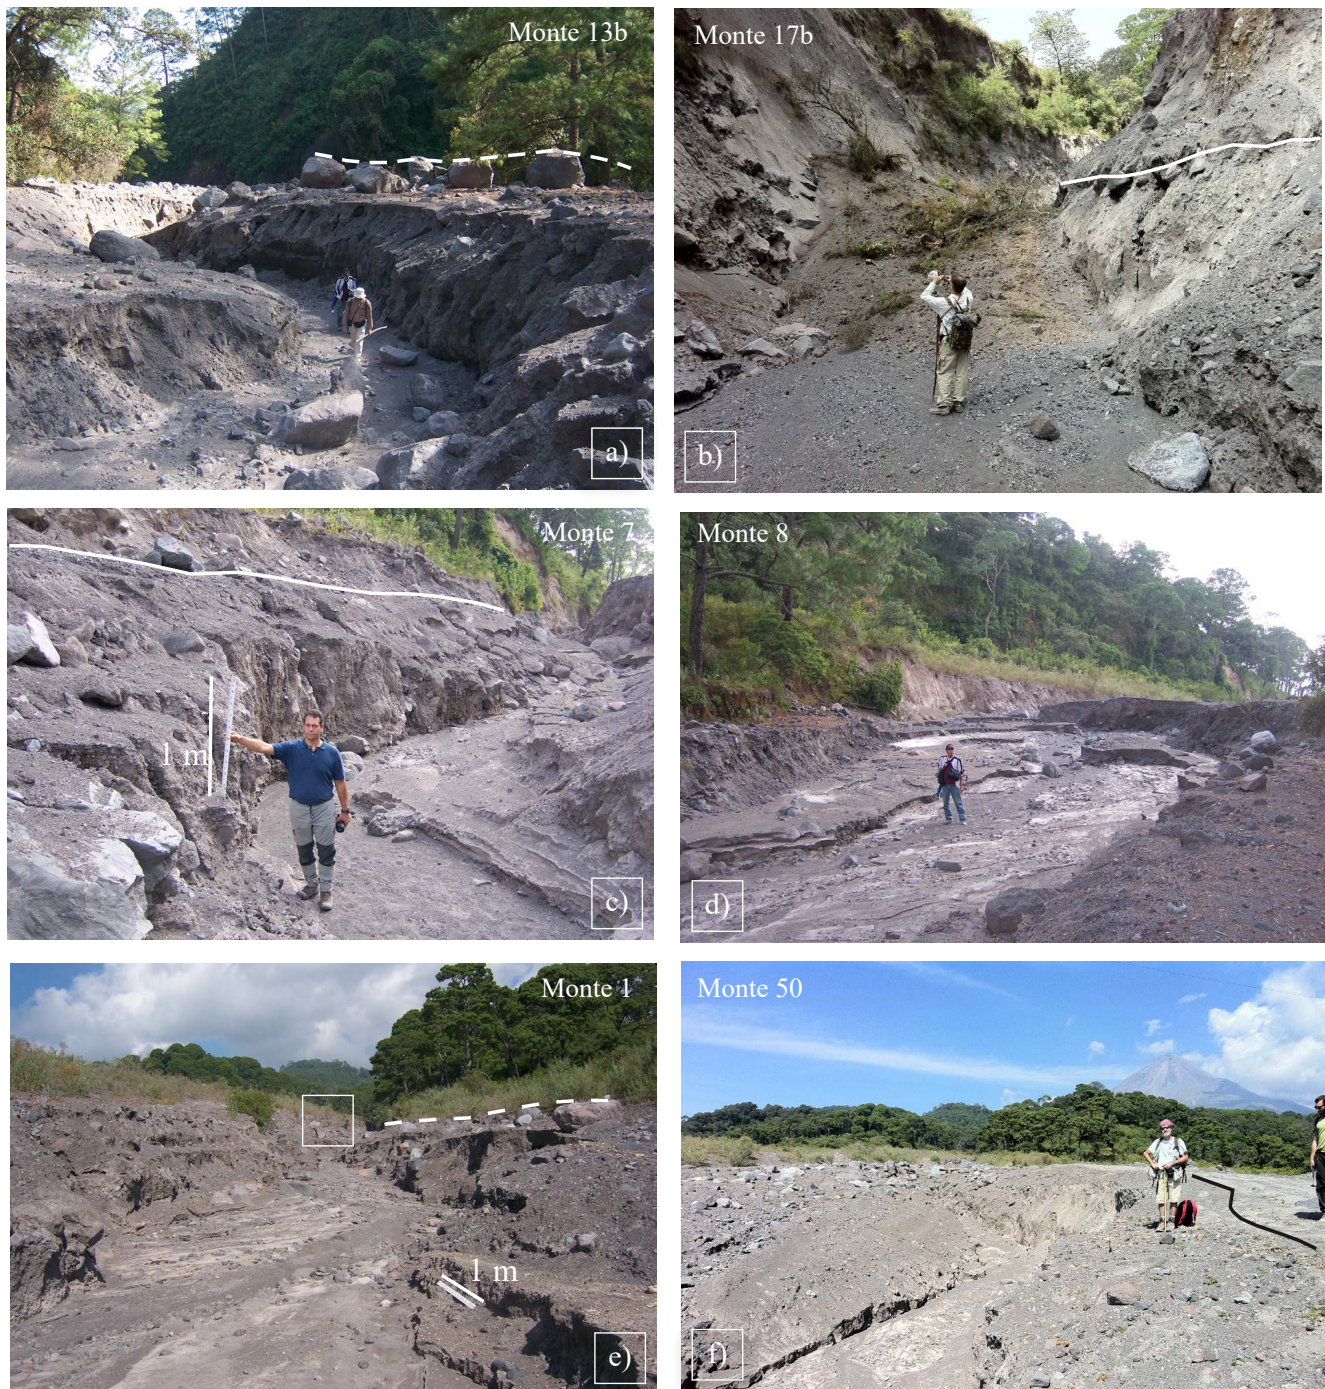
Figure 5. Photographs taken along the Montegrando ravine three days after the Jova lahar with evidence of flow depth (white line). a) Gravel and sandy patches on top of large boulder, b) erosive surfaces and small landslide, c) overbank deposits. Photos d), e) and f) show the change in width of the channel in the distal area. The location of each site is indicated in Figure 7.

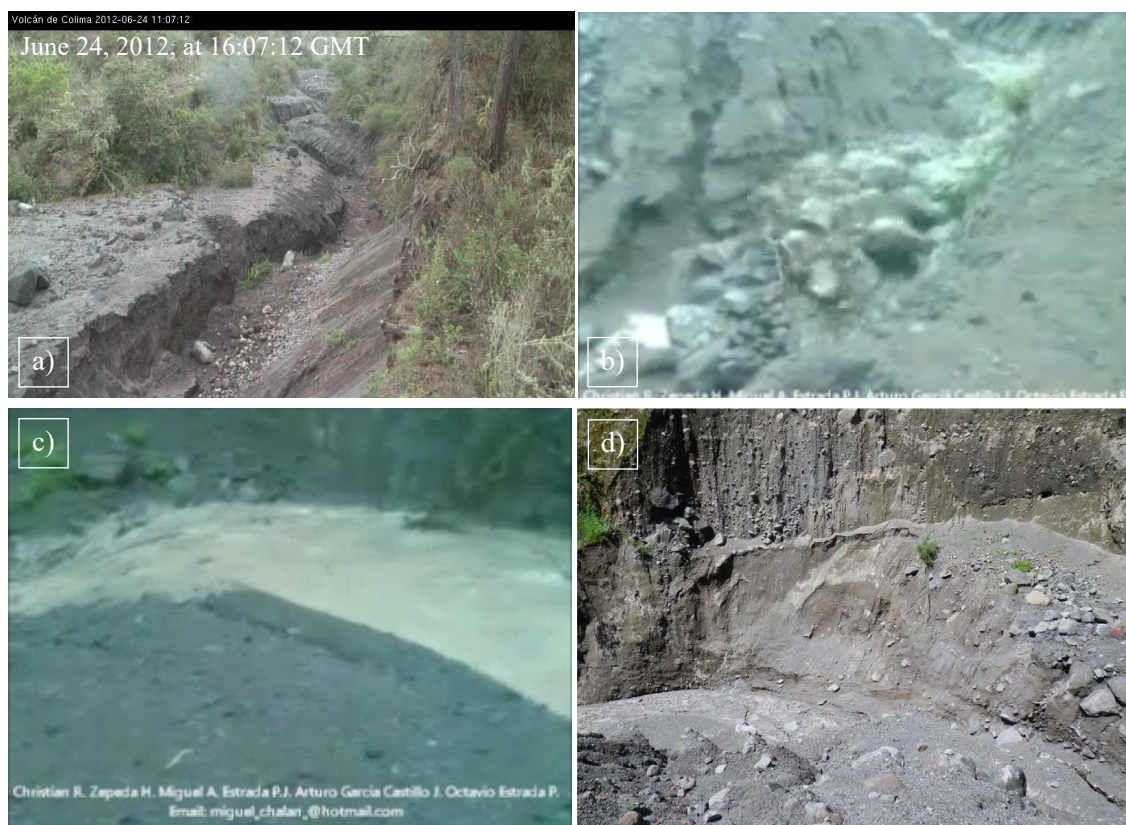
Figure 12. Still image showing the Montegrande ravine prior (a) and during the arrival of the block-rich front of June 25, 2012, lahar. The front of the flow is characterized by a boulder-dam with interstices filled with slurry matrix; c) Photo showing the lahar overflowing the obstruction and d) after the obstruction was eroded entirely.
